# Causes of and Countermeasures against Degradation of Discharge Flow during Operation Confirmation of System B of the Glass Melter

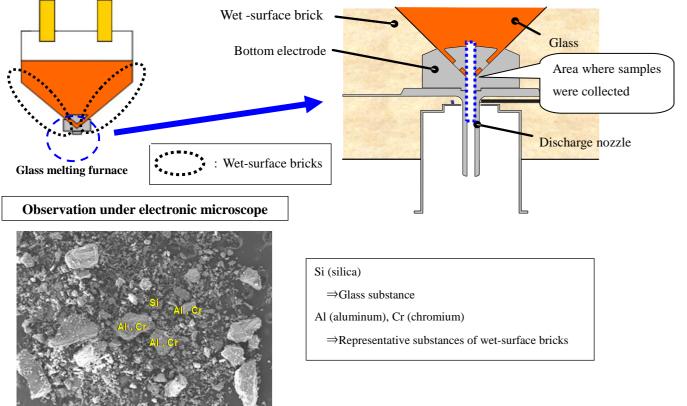
#### (1) Analysis of the samples collected from the foreign materials removal process

• The samples which were collected from the discharge nozzle, major substances of the bricks (wet-surface bricks) that came into contact with the glass inside the furnace were found, in addition to glass substance..

· Representative substances of ceiling bricks and glass ceramics were not found.

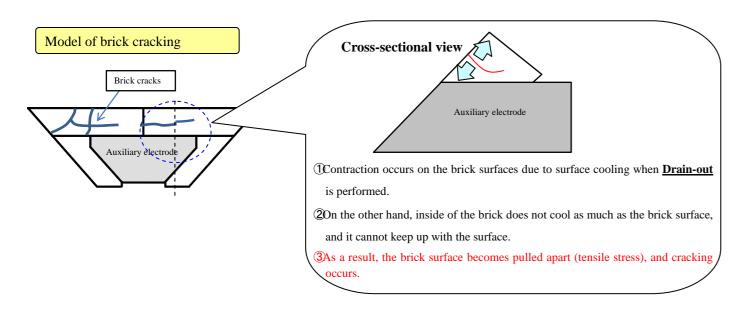
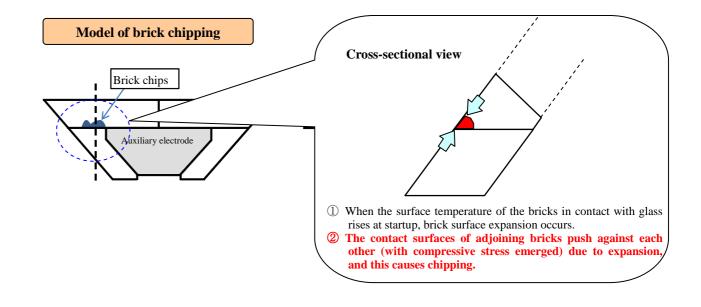
## (4) Evaluation of impact on bricks at furnace Startup /Shutdown

· Investigated the temperature trends at the base of the furnace at the time of the glass melter Startedup/Shutdown, and reviewed the impact on the bricks by means of stress analysis.

### • As a result, bricks were found to be susceptible to ;

#### 1. Cracking at the time of drain-out due to surface tensile stress of the wet-surface bricks

When drain-out is performed after the glass has been removed from inside the furnace, the interior cools more rapidly than in the case of shutdown, due to the air flow in the furnace, the stress of the bricks will be much greater.

#### 2. Chipping at Startup operation, as a result of compressive stress due to expansion of the bricks.

\*The bricks are subjected to greater stress at the time of Startup operation compare to the Heating operation which is when the furnace is gradually started up while placing glass inside the furnace.

$\Rightarrow$  Once cracking and chipping occurs, the stress is alleviated, thus new cracks and chips are unlikely to occur.

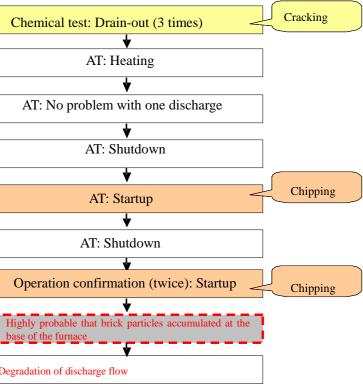
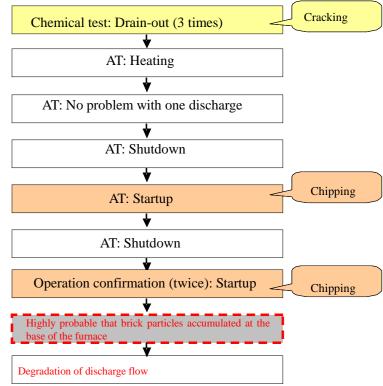
## 3. Presumed cause of discharge flow degradation

· From the above mentioned examinations, it has been concluded that the following results were identified as highly probable causes.

- ♦ Cracking occurred at the time of Drain-out (Chemical test), and chipping occurred at the time of Startup (Active test), creating brick particles.
- ◆ Since discharge was carried out only once in the two Shutdowns and Startups during the long term standby of 3.5 months, this has resulted in brick particles accumulation.

## (① Curtail the generation of brick particles)

- Perform the glass melter Startup and Shutdown operations with gradual temperature changes.
- In principle, drain-out should be performed so as to avoid startup where there is a high probability of chipping which leads to degradation of discharge flow.

## 2 Inhibit accumulation of brick particles

• When Shutdown is performed as a trouble prevention measure or when unscheduled Shutdown occurs due to power failures, purge the furnace of brick particles.

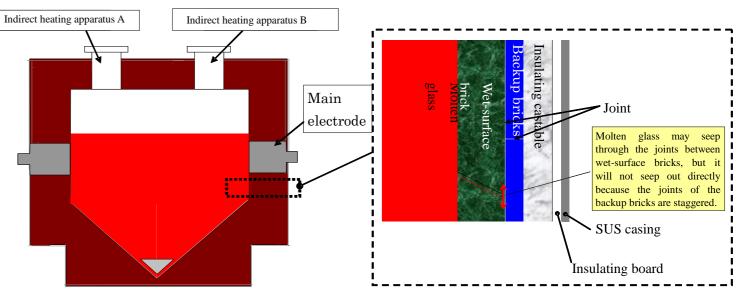
- · From the results of observations of the inside of the furnace, it is judged that there is no problem or serious damage that could impact operation or integrity of the glass melter. In addition, because further formation of cracks and chips are unlikely and measures to mitigate them have been implemented, the furnace is evaluated as operable hereafter even with cracks and chips existing on wet-surface bricks.
- The assessment of cracks and chips on the wet-surface bricks from the standpoint of safety of the furnace is as follows.

- It was confirmed through the assessment that even if the molten glass seeps into joints and cracks, the temperature of the glass goes down, and the liquidity of the glass slows down and stops, as it escapes toward the outside.
- The atmosphere of negative pressure is maintained inside the furnace by means of the vitrification waste gas processing unit.

- Earthquake resistance of the glass melter is evaluated on the basis of the strength of the casing.
- \* The maximum temperature at which the casing can be used is calculated as part of the evaluation of seismic resistance, but, it was confirmed through the assessment that the maximum casing temperature is not reached even in the situation when there are no wet-surface bricks.
